REPAIR, STRENGTHENING, AND RE-USE OF STEEL GIRDER BRIDGES: TWO CASE STUDIES

Lincoln Avenue Bridge Strengthening and Re-use

Hawthorn Parkway Bridge Repair

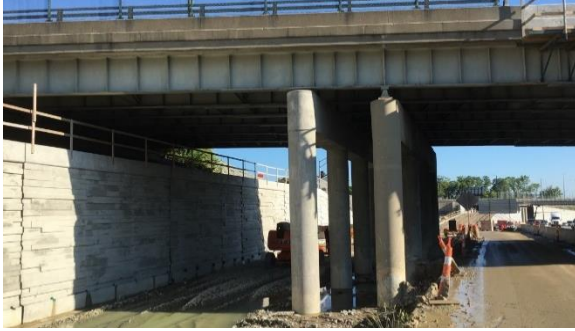
Figure 3: New Pier 1 Constructed to the West (left) of the Existing Pier 1.

The new span arrangement to accommodate the widened I-71 corridor resulted in the need for a new Pier 1 to be reconstructed nearly 10' closer to the Rear Abutment. The new pier is similar to existing pier in that it is a 4-column cap and column pier, and utilizes individual spread footings on rock for each column. Each new footing is 9'-6" by 9'-6" in plan. Due to the close proximity of the new pier with the existing, two of the existing column spread footings were in conflict with the new pier spread footings, with a maximum overlap of nearly 1'-6". The new pier is aligned on a slightly different angle from the existing pier due to the new I-71 alignment, and thus only two footings were in conflict. Through analysis of the existing bridge in combination with recent geotechnical information, it was determined that the existing foundations could be partially removed to accommodate the new spread footings, and was thus the method used to allow construction of the new pier. Figure 3 shows the new pier constructed next to the existing pier.

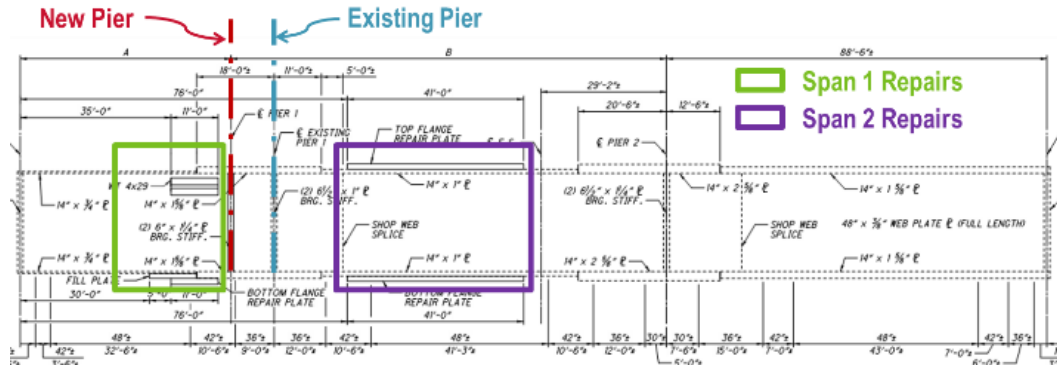
The change in span arrangement resulted in required strengthening repairs to all girders in the superstructure. The new span arrangement causes a shift in the major-axis bending moment diagram. This behavior is generally illustrated in Figure 4. Of course, due to the increased center span length by approximately 10', the maximum positive moment in the final condition is substantially increased over the existing design major-axis bending moment. The maximum negative major-axis bending moments do not substantially increase, however the location moves because of the Pier 1 relocation. The negative moment area in Span 1 changes, with more of the span subjected to negative moment. The increase in maximum positive moment in Span 2 and the shift of the negative moment area into more of Span 1 resulted in girder strengthening repairs in these areas. Conversely the existing girders in Span 3 required no additional strengthening.

Figure 5: Girder Elevation With Repair Locations Noted.

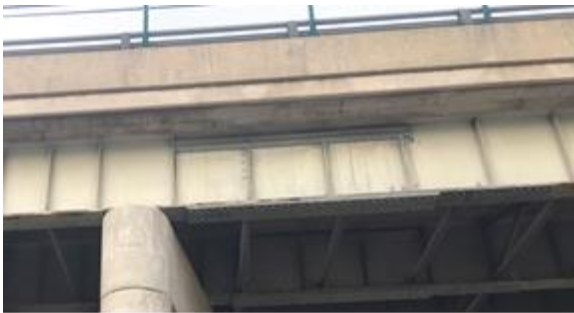
The Span 1 repair was unique in that it was developed so the deck did not need to be removed. The shift in the moment diagram resulted in stresses that exceeded the resistance of the existing flanges at the flange transition point now 8' away from Pier 1. This flange transition was 18' from Pier 1 in the existing configuration. Two strengthening plates were added to the bottom flange transition location to adequately transfer new bottom flange forces resulting from increased live load, and dead load effects caused by relocating Pier 1. Because the bottom flange could be in reversal in this area, the repair plates were bolted to the existing flanges. A WT 4x29 section was added to each side of the web at the flange transition location, and they were located near the top of the web. These WT members help to increase the moment of inertia at this location, thus reducing the applied stresses in the top flange such that they were less than the flange resistance. The length of the repair assemblies were designed to adequately transfer forces from the existing girder, into the repair assemblies, and then back into the existing girder. The use of these WT's in combination with the bottom flange repair made it unnecessary to access the top flange by removing the concrete deck.

Also note, new bearing stiffeners were required at the new Pier 1 support. Figure 6 shows the Span 1 repair assemblies installed on a fascia girder prior to installation of the new bearing stiffeners.

Figure 6: Span 1 Repairs Installed in Fascia Girder.

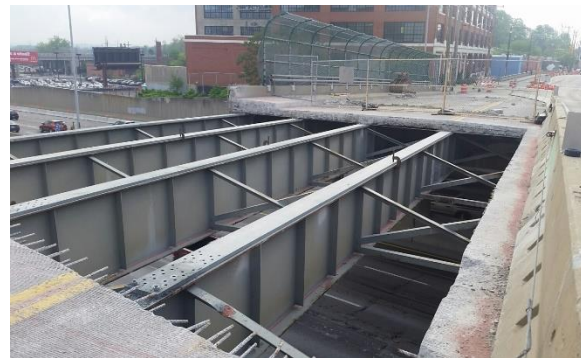
The Span 2 repair in the center span utilized more conventional girder strengthening details. The repairs were required because of the substantial increase in the live load moments, and additional dead load moment caused by the relocation of Pier 1. Strengthening plates were added to the top and bottom flanges, with each measuring 41' in length and nearly centered in the new Span 2 length. The bottom repair plate was completely bolted to the existing bottom flange. The bottom repair plate was the same width as the existing bottom flange. The top repair plate was welded to the top flange except at the ends which were bolted to provide a means for adequately transferring forces back into the existing top flange. The ends of the top flange repair plate were also subjected to a limited amount of moment reversal and thus subjected to tensile forces. Welding to the member locations subjected to tension was not permitted. The top flange repair plate was not as wide as the existing top flange. One-inch of clearance was provided on each side of the repair plate so that it could be welded to the existing top flange from above.

Figure 7: Phase 1 of the Span 2 Repairs with Deck Removed.

deck removal and replacement occurred in two phases, maintaining two lanes of traffic on the bridge at all times. The first phase was used to make repairs on the 4 girders on the south side of the bridge (Figure 7), and the second phase was used for the remaining 3 girders (Figure 8). Mechanical connectors were used in the concrete deck at the phased construction to eliminate the need to lap the transverse steel reinforcement at this construction joint.

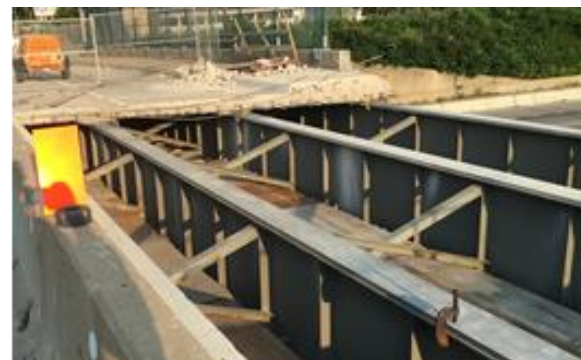
Figure 8: Phase 2 of the Span 2 Repairs with Deck Removed.

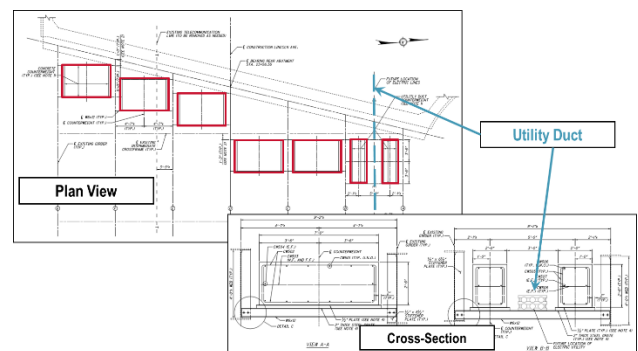
The less than ideal new span arrangement resulted in net uplift at the Rear Abutment. Live load placement in Span 2 would cause uplift reactions that could overcome the downward dead load reactions, using factored load combinations. There was no net uplift considering unfactored load combinations. The net uplift was resolved with the placement of counterweights in Span 1. As shown in the plan view in Figure 10, the counterweights were located as close as possible to the Rear Abutment.

Figure 10: Counterweights Provided Near the Rear Abutment.

Two different types of counterweights were required. A 5' (Length) x 7' (Width) x 2'-6" (Height) was used in all bays except for the northern exterior bay. A utility duct was to remain in place in this exterior bay. Therefore, two concrete counterweights were used, with each having dimensions of 7' (Length) x 2' (Width) x 2'-6" (Height). The counterweights were formed and cast in place since the Span 1 deck remained in place. A steel framing system had to be installed to support the counterweights. This included new connection plates on the girders if the existing stiffeners could not be used, W6x12 support beams spanning between the girders, steel grating, and 1/2" steel plates.

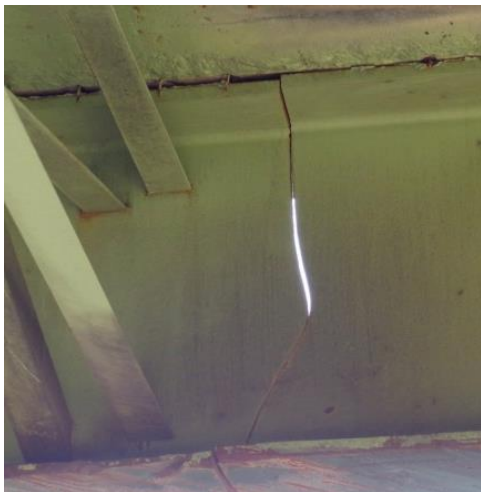
On August 7, 2014, a full-depth crack in the fascia beam was discovered during a routine annual bridge inspection being performed by the Ohio Department of Transportation (ODOT) District 12 (See Figure 13). The bridge was subsequently closed to vehicular traffic, and an emergency temporary web splice plate was added to the bridge. The bridge remained closed to traffic until a permanent repair was made.

Figure 13: Full-depth Crack in Fascia Beam.

Furthermore, visible damage could be seen on the bottom flange of the fascia and adjacent interior beams where vehicles have impacted the bridge. The fascia beam had been heat straightened once in 1987 and again in 2005. Through a General Engineering Services contract with ODOT District 12, HDR was engaged to investigate repair solutions and subsequently develop construction plans for the repair. In addition to developing repairs for the cracked beam, the project also included general

- the replacement of the fascia beam from field splice 2 to field splice 3 with a same depth section, removing the damaged beam section
- the raising the structure 4" at each support to improve vertical clearance
- the consideration of future plans by ODOT D12 that would lower US 422 as part of a future resurfacing project.

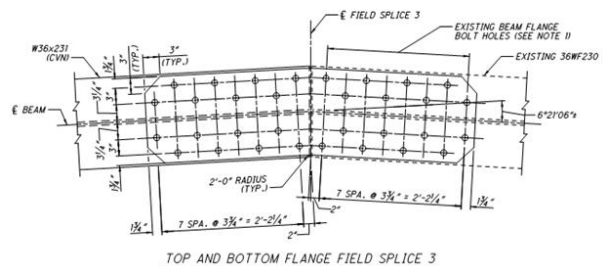
Figure 14: Flange Splice Plates for Field Splice 3.

Since the beam section was being replaced between two existing field splices, the existing bolt holes were used on the two beam sections that remained in place. The contract plans noted that the existing field splice plates were to be used as templates for drilling the holes on the new splice plates and the new beam section, eliminating potential fit up issues with the beam sections that remained in place. A flange splice detail is shown in Figure 14.

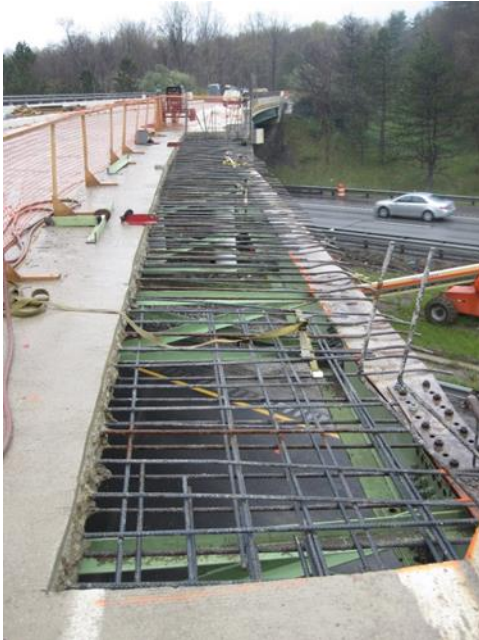
Figure 15: Deck Removed, Existing Beam Still in Place.

A 7'-4" by 65'-8" portion of deck above the beam field section was to be removed and replaced, as shown in Figure 15. Temporary support locations and jacking forces to ensure proper beam fit up during installation were provided on the contract plans as well.

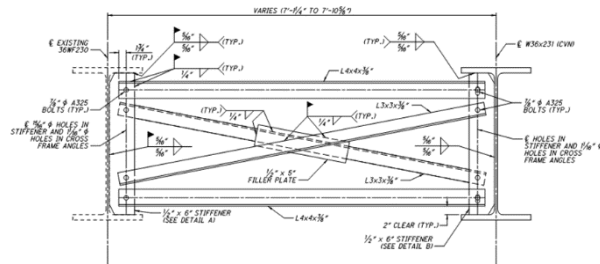
Figure 16: Typical New Cross-frame and Connection Stiffeners.

It was necessary to install the new beam section and provide bracing to prevent lateral torsional buckling of the beam during the partial deck replacement. To accomplish this, only the top and bottom strut of the cross-frames attaching the new beam to the adjacent beam were initially installed and connected at both ends, prior to placing the deck. To allow the new beam to deflect as a result of the wet concrete, vertically slotted holes were provided on the connection stiffener on the girder. This would allow for the struts to act similar to “lean-on” bracing, but also allow the new beam to vertically deflect as concrete was placed (See Figure 16).

Upon completion of the deck placement, the diagonals could be connected, and then all members field welded to the connection stiffeners. Note that a new connection plate on the existing adjacent girder was also required. Existing cross-frame members utilized the ODOT standard detail of welding the member directly to the web. This type of connection does not allow the movement needed to accomplish this repair, and thus the connection stiffeners were

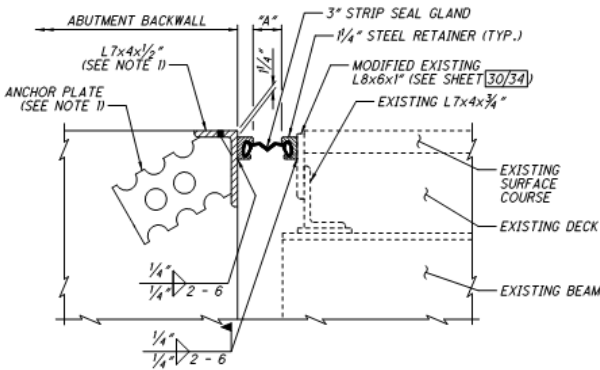
Figure 17: Expansion Joint Replacement Detail.

The existing sliding plate expansion joints at each end had to be replaced since the bridge was being raised. The new detail utilized portions of the existing joint armor on the deck side, in combination with a new strip steel assembly, as shown in Figure 17. The existing L8x6x1 angle on the side of the existing deck was modified by cutting the horizontal leg, and then welding the steel retainer for the new strip seal gland. A portion of the abutment backwall was to be removed and replaced due to raising the bridge, so access was provided to make the necessary modifications. See Figure 18 for a comparison of the existing and new expansion joint.

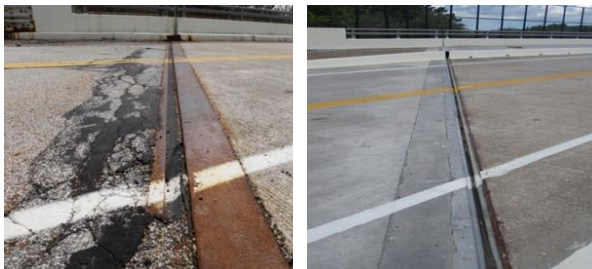
Figure 18: Expansion Joint Replacement (existing at left, new at right).

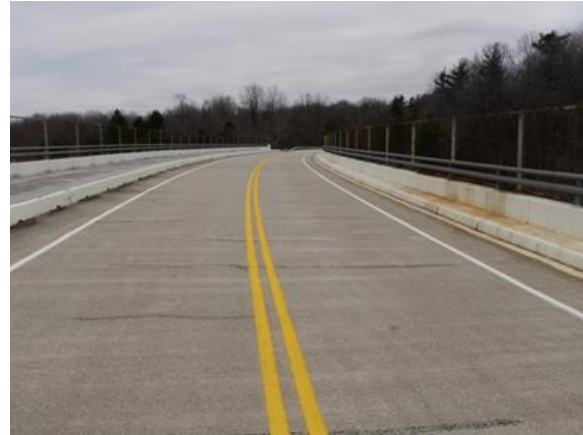
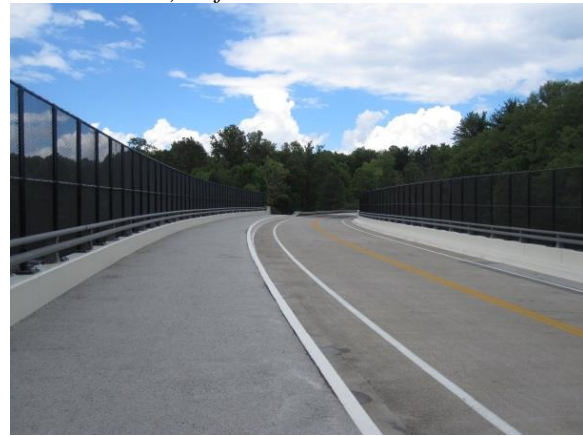
a) Before Rehabilitation

b) After Rehabilitation

Figure 21: Overall Bridge Rehabilitation Comparison.

Aesthetic improvements benefited those crossing the bridge via vehicle, as well as those who use the bridge for recreation purposes within the Cleveland Metroparks. The existing and deteriorated fence was removed from the bridge. The existing fence attached to the outside of the bridge parapet. A new fence was installed that attached to the top side of the bridge parapet. The parapets and deck overhangs on each side of the bridge were sealed to provide a better looking finish. The bridle path riding surface on the bridge was also replaced. Figure 21 shows the upper surface of the bridge before and after the repairs.
