REPAIR, STRENGTHENING, AND RE-USE OF STEEL GIRDER BRIDGES: TWO CASE STUDIES

Lincoln Avenue Bridge Strengthening and Re-use

Hawthorn Parkway Bridge Repair

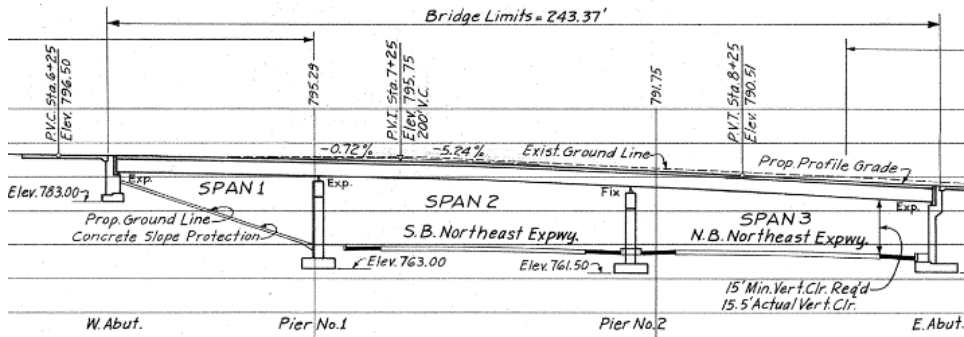
Figure 1: General Elevation View of the Existing Lincoln Avenue Bridge.

The Lincoln Avenue Bridge is a straight three-span continuous steel plate I-girder bridge originally constructed in 1969 with span lengths of 59'-0" - 91'-4" - 88'-6", and all supports skewed at 13.5 degrees. Figure 1 shows a general elevation view of the existing bridge prior to any new work. The bridge crosses over I-71 in the northeast section of the City of Cincinnati, Ohio. The bridge deck has a total width of 60'-4", which includes four lanes of vehicular traffic and 6'-10" sidewalks on each side of the bridge. The non-composite deck is supported by seven steel I-girders spaced at 9'-2".

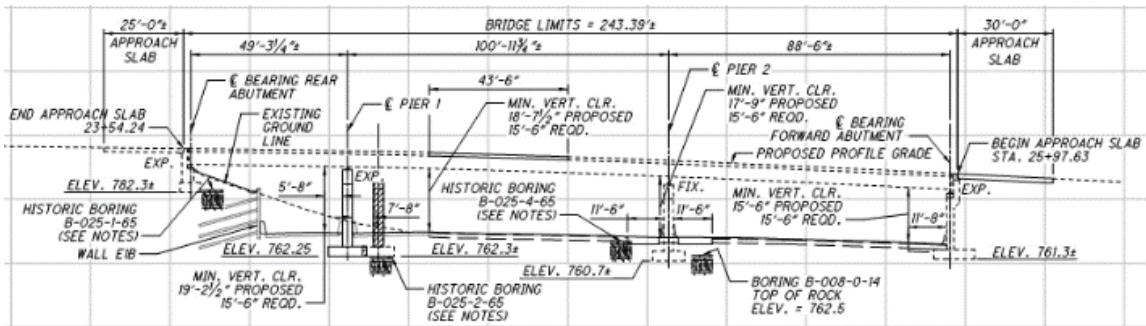
Figure 2: General Elevation View of the Proposed Lincoln Avenue Bridge.

Below the Lincoln Avenue Bridge, a new ramp lane was cut into the existing slope below Span 1 and the lane arrangement was widened below Span 2. A soil nail wall was installed in front of the Rear (West) Abutment to allow the new ramp lane below Span 1. To accommodate the new I-71 mainline lane arrangement beneath the bridge, the first interior pier was relocated nearly 10' closer to the Rear Abutment, increasing the center span (Span 2) length, and resulting in a new span arrangement of 49'-3" - 101'-0" - 88'-6". It can be seen that an already poor span arrangement was made worse by the span reconfiguration, such that the first end span is less than 50% of the center span length. Figure 2 shows a general elevation view of the new span arrangement and I-71 lanes below.

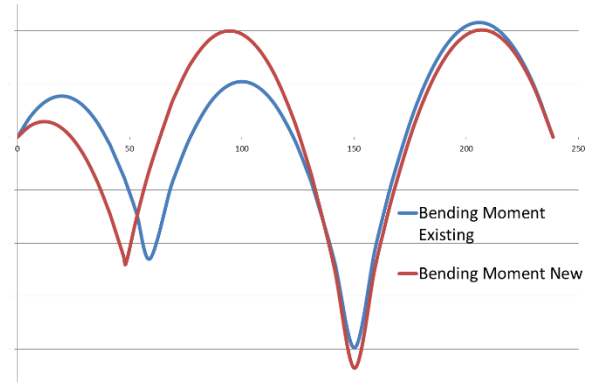
Figure 4: General Shift in Major-Axis Bending Moment Diagram Caused by New Span Arrangement.

The change in span arrangement resulted in required strengthening repairs to all girders in the superstructure. The new span arrangement causes a shift in the major-axis bending moment diagram. This behavior is generally illustrated in Figure 4. Of course, due to the increased center span length by approximately 10', the maximum positive moment in the final condition is substantially increased over the existing design major-axis bending moment. The maximum negative major-axis bending moments do not substantially increase, however the location moves because of the Pier 1 relocation. The negative moment area in Span 1 changes, with more of the span subjected to negative moment. The increase in maximum positive moment in Span 2 and the shift of the negative moment area into more of Span 1 resulted in girder strengthening repairs in these areas. Conversely the existing girders in Span 3 required no additional strengthening.

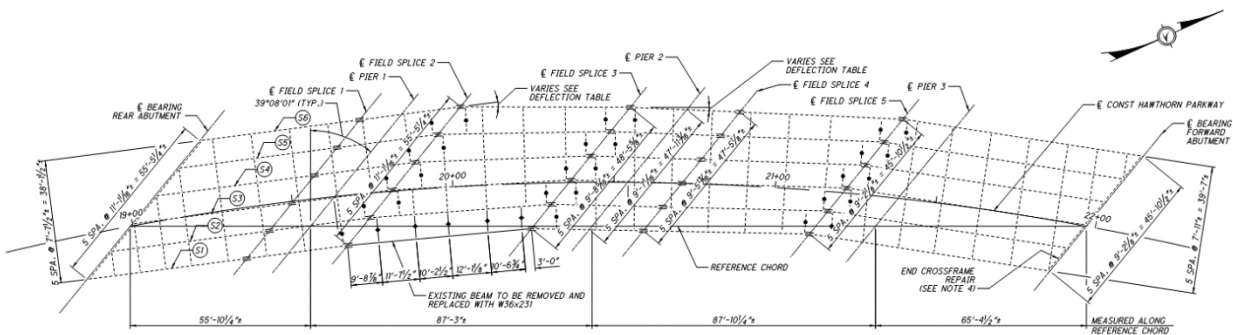
Figure 12: Framing Plan of the Hawthorn Parkway Bridge

The Hawthorn Parkway Bridge is a curved four-span continuous chorded steel beam bridge, with all supports skewed at 40 degrees with respect to the reference chord, and with spans of 64'-0" - 91'-0" - 84'-0" - 59'-0". A framing plan of the bridge is shown in Figure 12. The non-composite concrete deck is supported by 6 wide flange beams with variable spacing along the length of the bridge. The bridge carries Hawthorn Parkway over US 422 in the City of Solon, Ohio, and is located within the Cleveland Metroparks. The bridge carries two lanes of vehicular traffic, as well as, a bridle path used for horseback riding.
